# Manhole Inspection Summary

Manhole # S27A\_\_032MH

Insp Date: **12/4/07 11:08 AM**

**Location** Address: **801 GEORGE ST**

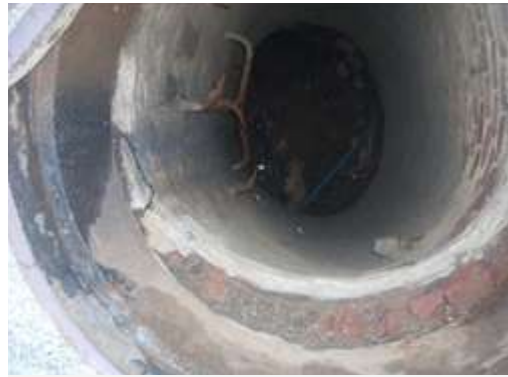
Offset: **3** (in.)

FRAME OFFSET

Defect 3

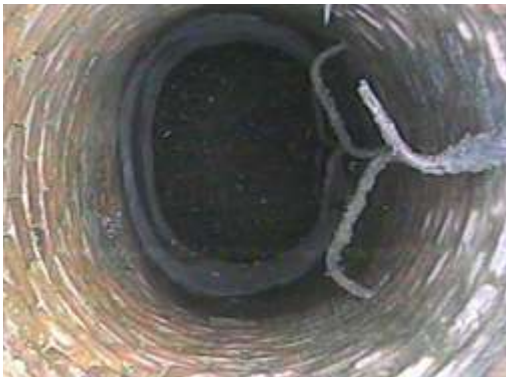
Condition: ☐ Sound ☐ Cracked ☐ Root Intrusion ☐ Deteriorated ☐ Leaks ☒ **Debris**

CHANNEL DEBRIS

Defect 3

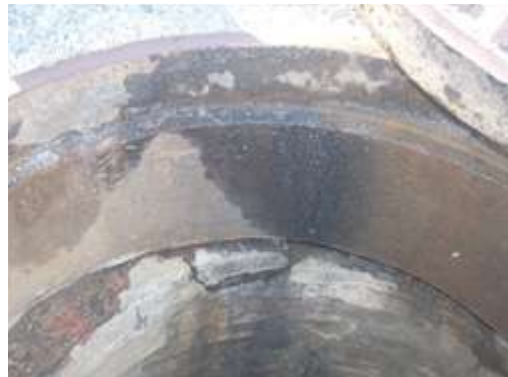
Condition: ☐ Sound ☒ **Cracked** ☐ Root Intrusion ☐ Loose Brick ☐ Deteriorated

Infiltration: ☐ None ☐ Joint ☐ Cracks ☐ Mortar ☐ Roots ☒ **Wall**

CRACKED CORBEL/INFILTRATION  
CORBEL WALL

Defect 2

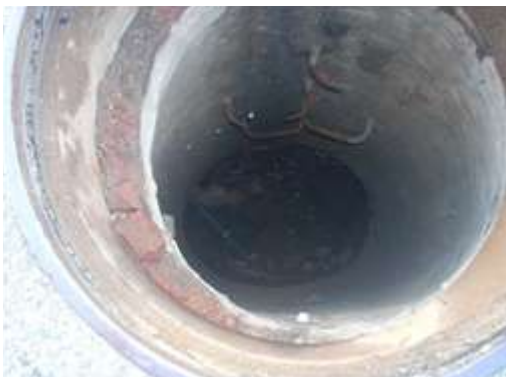
Count: **4** Missing: **2** ☒ **Corroded**

MISSING AND CORRODED STEPS
